Manhole Inspection Summary

Manhole # S09CC1005MH

Insp Date: **6/25/07 10:19 AM**

Location Address: **3817 CALLAWAY AVE**

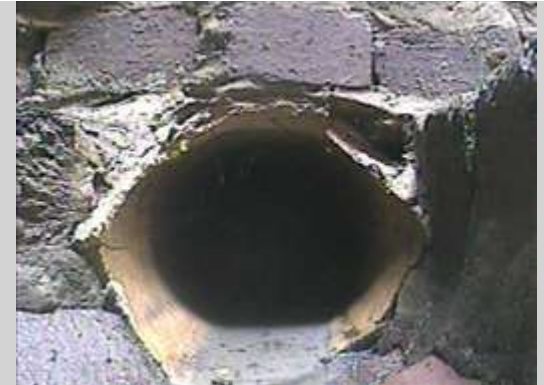
12 O'Clock Outflow

6 in. Circular Gravity Sewer
Pipe Out @ 12 O'Clock

Pipe Height: (in.) Direct
Pipe Material: **Clay** ☐ Pipe Lined
Invert Depth: **6.96** (ft.) Flow Characteristics: **Slow**
Deposits: ☒ None ☐ Mud ☐ Sludge ☐ Debris ☐ Grease
Silt Depth: (in.) Deposits Extent:
Infiltration: **None** Pipe Seal Cond: **Broken**

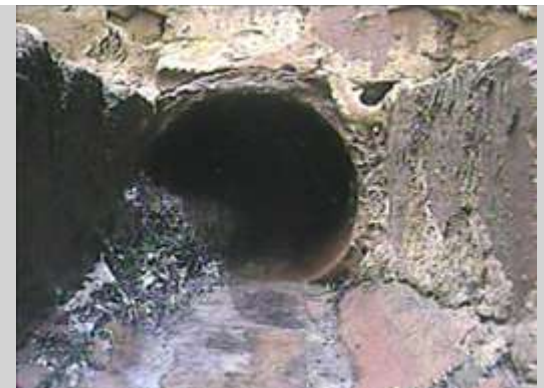
6 O'Clock Inflow

6 in. Circular Gravity Sewer
Pipe In @ 6 O'Clock

Pipe Height: (in.) Direct
Pipe Material: **Clay** ☐ Pipe Lined
Invert Depth: **6.91** (ft.) Flow Characteristics: **Slow**
Deposits: ☒ None ☐ Mud ☐ Sludge ☐ Debris ☐ Grease
Silt Depth: (in.) Deposits Extent:
Infiltration: **None** Pipe Seal Cond: **Broken**

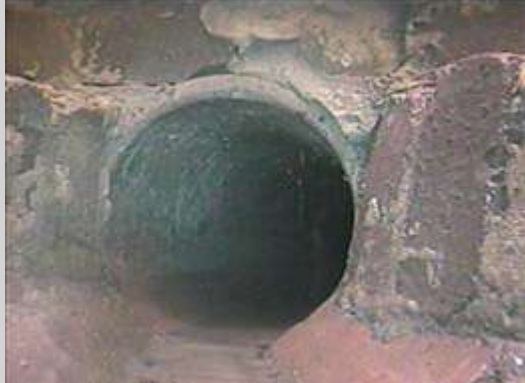
9 O'Clock Inflow

6 in. Circular Gravity Sewer

Pipe In @ 9 O'Clock

Infiltration: **None** Pipe Seal Cond: **Sound**
